United Nations Mission to Investigate Allegations of the Use of Chemical Weapons in the Syrian Arab Republic

Report on the Alleged Use of Chemical Weapons in the Ghouta Area of Damascus on 21 August 2013

Report on Allegations of the Use of Chemical Weapons in the Ghouta Area of Damascus on 21 August 2013

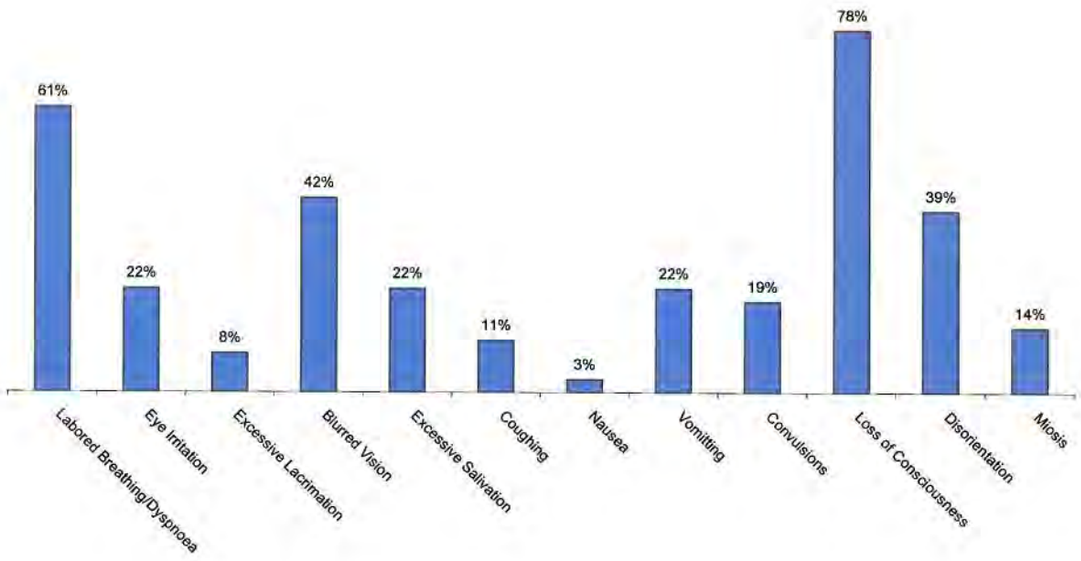
Chart: Symptoms and signs of survivors (N=36)

The main symptoms reported by survivors included loss of consciousness (78%), shortness of breath (61%), blurred vision (42%), eye irritation/inflammation (22%), excessive salivation (22%), vomiting (22%), and convulsions/seizures (19%). The full range of symptoms and signs are presented in the chart below.

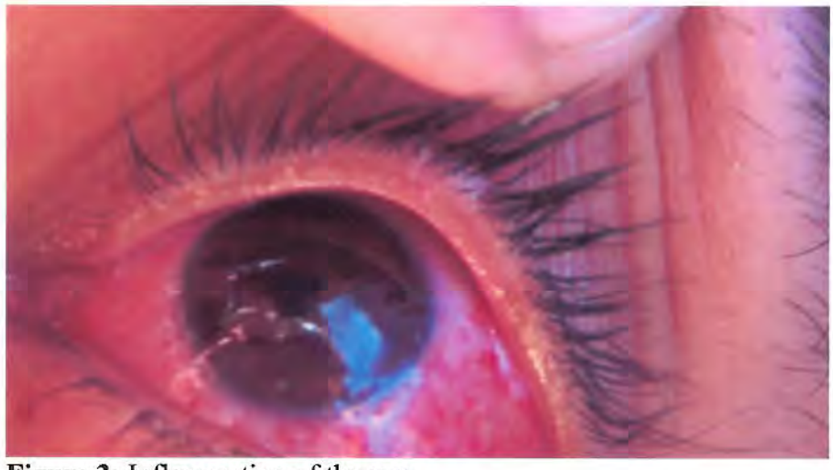
Figure 2: Miosis (constriction of pupils)

Physical examination demonstrated that 39% of survivors were confused or disoriented at the time of the assessment and that 14% had miosis (constriction of pupils) (Figures 2 and 3).

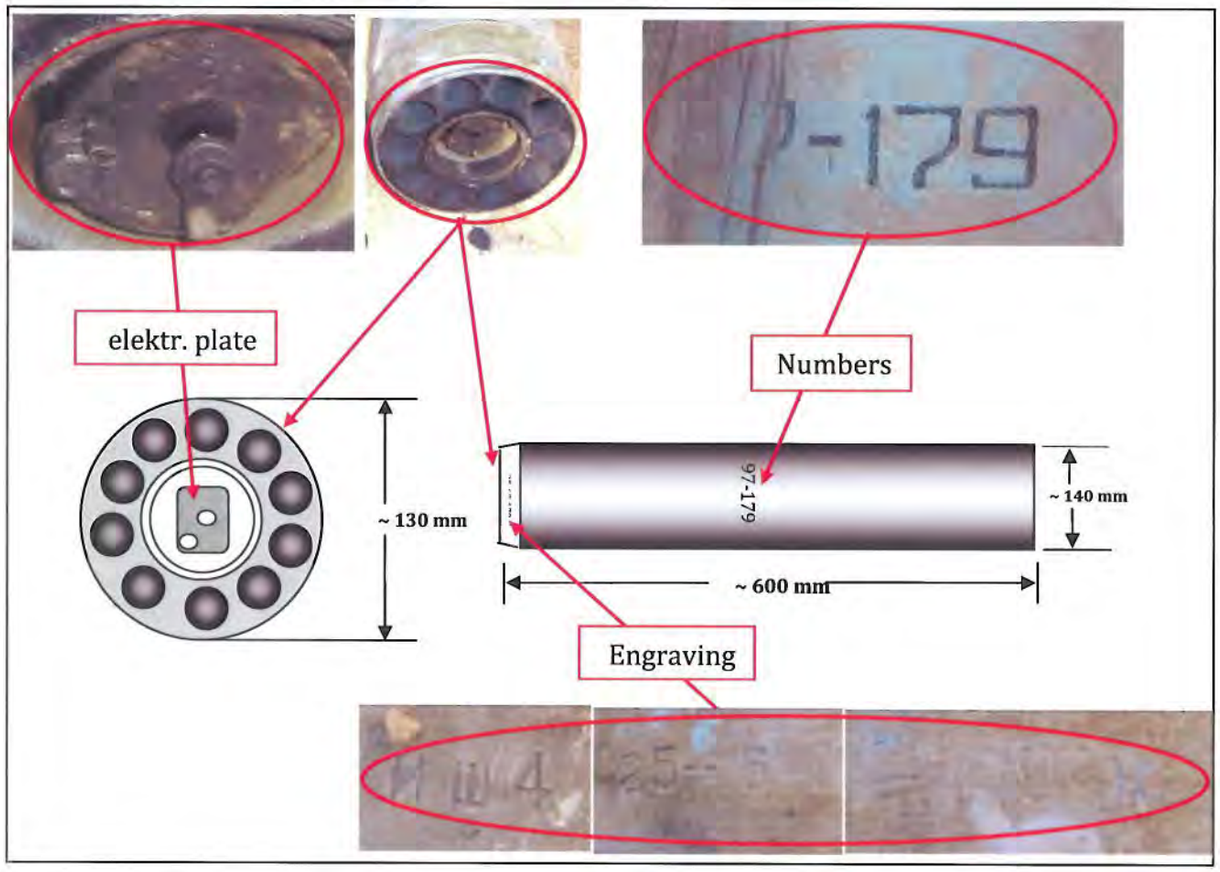
The engine had 10 jet nozzles ordered in a circle at the end of the rocket with a metal electrical contact plate in the middle.

Limitations:
The time necessary to conduct a detailed survey of both locations as well as take samples was very limited. The sites have been well travelled by other individuals both before and during the investigation. Fragments and other possible evidence have clearly been handled/moved prior to the arrival of the investigation team.

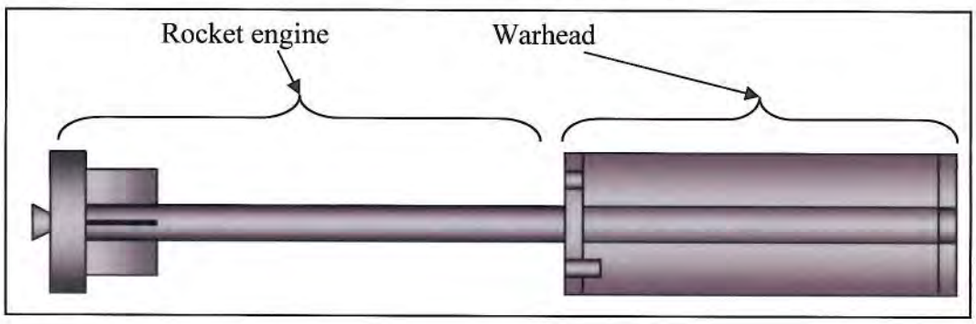
Observations and assessments from the Zamalka/Ein Tarma findings:
One team moved to the location of an alleged munition impact located on the roof of a five story building, the second team moved to another alleged impact point located in a nearby open field.
The two teams worked in parallel and identified the same type of munition at both sites. The munition had features noted as being consistent with that of an unguided rocket.
All measurements and dimensions are the result of both team findings. Some rocket parts were deformed on impact and the measurements should be considered as best estimates.
Based on the orientation of the impact craters, orientation of certain surviving munition components and other damage in the areas, the rockets are believed to have arrived from the northwest.

Below is a drawing of the found ordnance, the body has been divided into two parts.

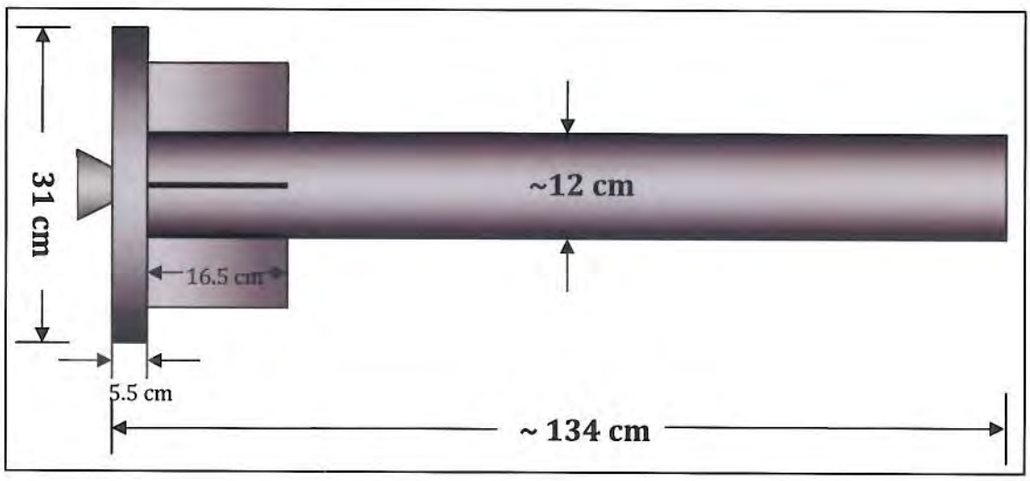
The rocket engine:
Six stabilizer fins are equally arranged in a circle and stabilized with a metal ring.
One rocket had a red number 153 sprayed in the middle of the engine tube.
The engine tube is attached to the warhead with 12 bolts.

- Total length of the engine: ~134 cm (exit nozzle not included)
- Length of rocket motor fins: ~16.5 cm
- Width of stabilizing ring: ~5.5 cm
- Length of motor exit nozzle: ~4.5 cm
- Length of motor engine shaft: ~112 cm
- Ø of engine shaft: ~12 cm
- Ø of stabilizer ring: ~31 cm

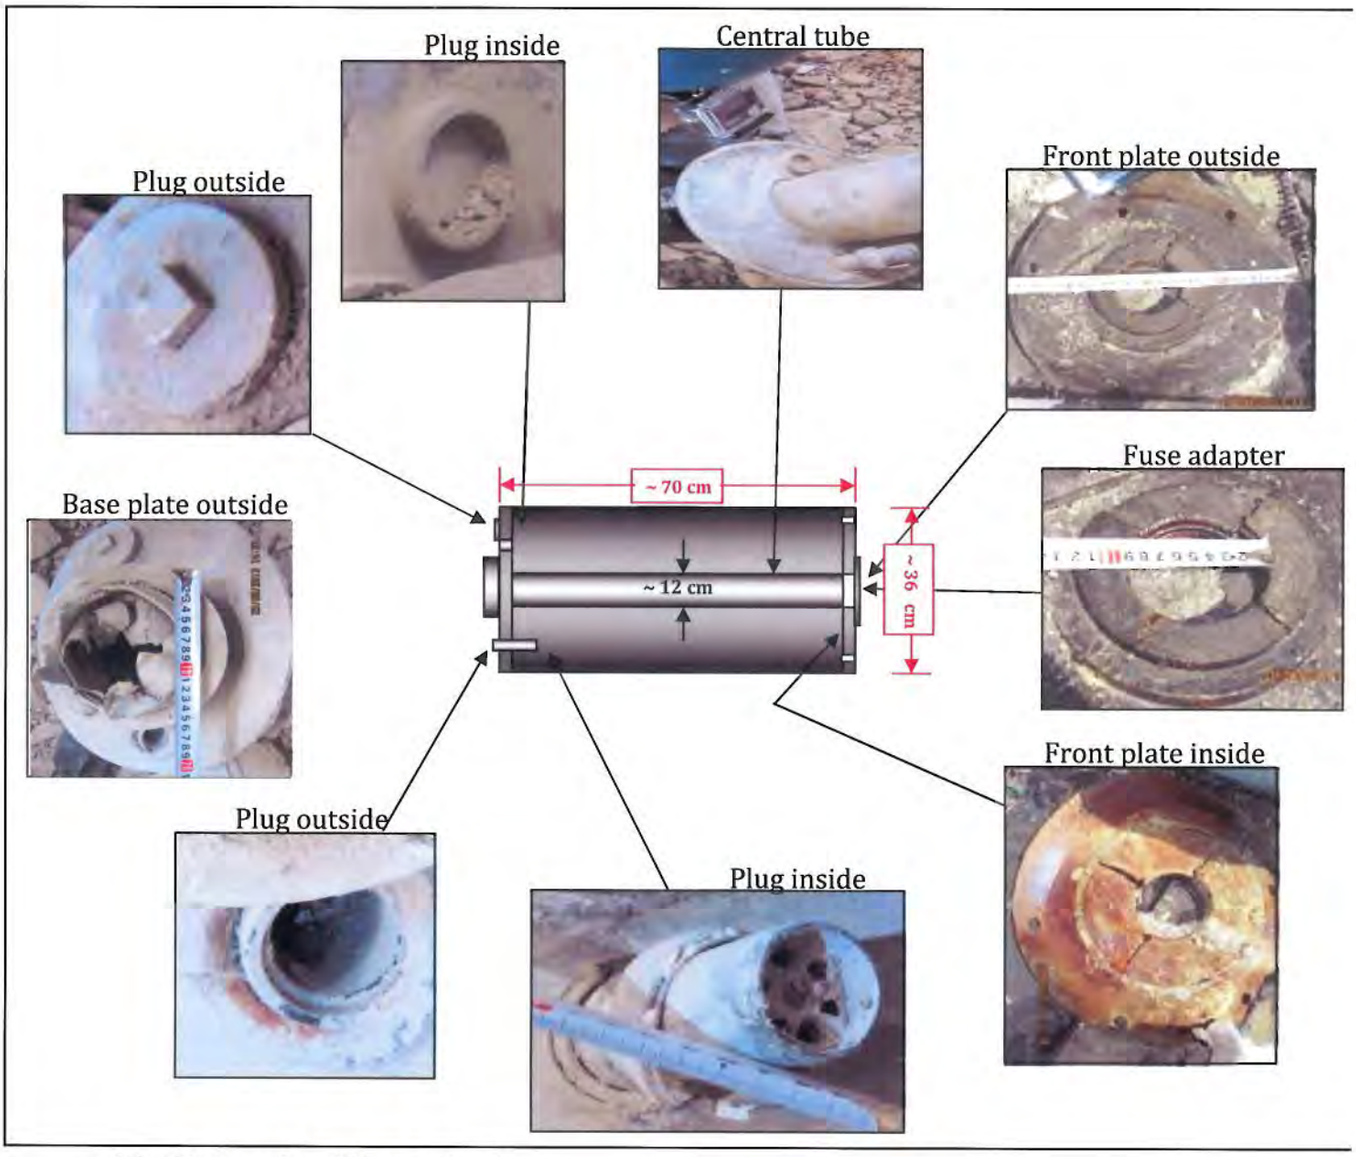
The warhead consists of:

- Front metal plate with a fuse thread in the center
  - Ø outside: ~ 36 cm
  - Ø fuse thread: ~ 9 cm

- Six threaded attachment holes are equally arranged in a circle near the outer ring

- Body / outer container consisting of metal plate
  - Thickness ~ 5 mm
- Metal base plate with filling plug, tube and attachment ring with 12 bolts.
  - Ø outside: ~ 36 cm
  - Ø square bolt ~ 7 cm
  - Ø integrated tube on the base plate ~ 3 cm
  - Length of the tube ~ 10 cm
- Central tube of the warhead
  - Length of tube: ~ 70 cm
  - Ø of the tube: ~ 12 cm

The approx. capacity of liquid in the warhead is according to the measurements between 56 ± 6 liters. This calculation is exclusive to the thickness of the container walls and any other unknown components possibly contained in the warhead.

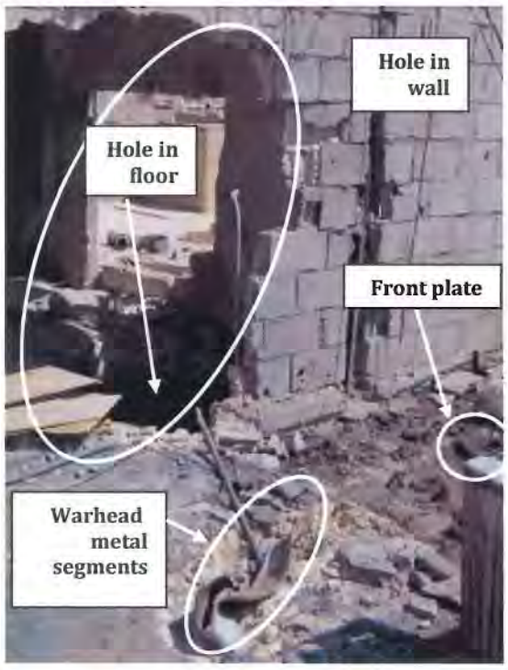
1. The rocket found by the sub-team on the roof penetrated a cinderblock wall and a rebar containing concrete floor before coming to rest in a room below. The suspected front plate of the warhead and other parts suspected of being the warhead casing were found in front of the first wall and not in the lower room. Additionally, they did not exhibit signs of significant deformation or damage due to kinetic impact. Based on the found evidence; there is an indication that the rocket warhead appeared to function prior to impacting on the roof, releasing its contents and depositing the discovered fragments before travelling through the structure to its terminal location. Apart from the rocket motor and the front central tube with the base plate, no other munition fragments were found in the lower room.

2. The front plate showed 6 symmetric threaded holes around the outline. It's unclear what part(s) are attached through these holes.
